Analysis Of Trees Damaged From Flooding And Ice In Columbus, Nebraska

ANALYSIS OF TREES DAMAGED FROM FLOODING AND ICE IN COLUMBUS, NEBRASKA

AN UNDERGRADUATE THESIS

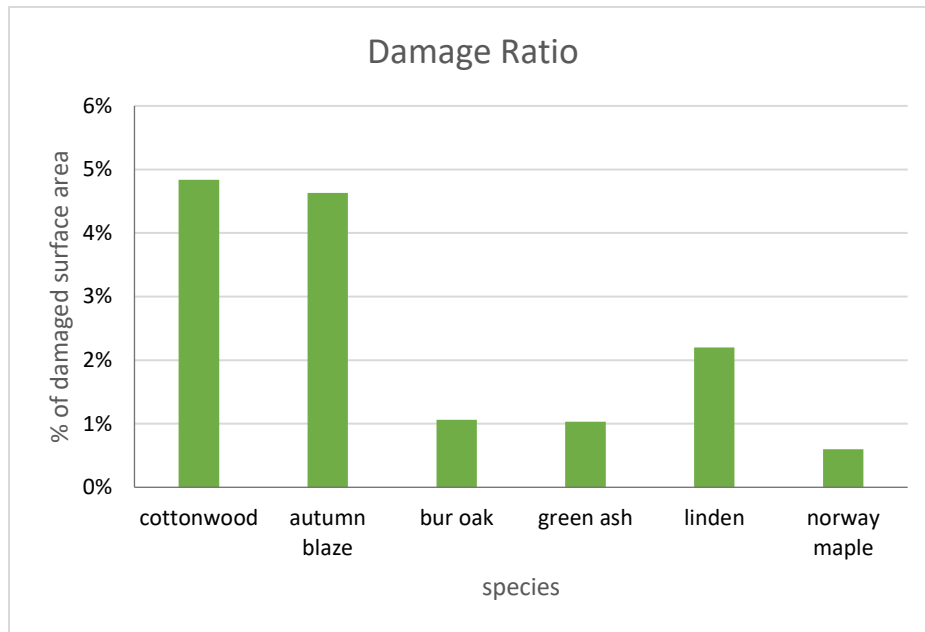
To calculate the percentage of the tree that had damage, the surface area of the tree was estimated using the height and circumference at breast height. Although circumference changes with height of the tree, this consistent calculation allowed an estimation of trunk damage. The average damage ratio is broken down by species in Chart 1.

*Chart 1. Damage ratio
by species*
